ASBESTOS SURVEY FOR FORT POINT U.S. COAST GUARD STATION

Presidio of San Francisco

**Prepared by:
R.L. Stollar & Associates, Inc.
Urie Environmental Health, Inc.**

September 1991

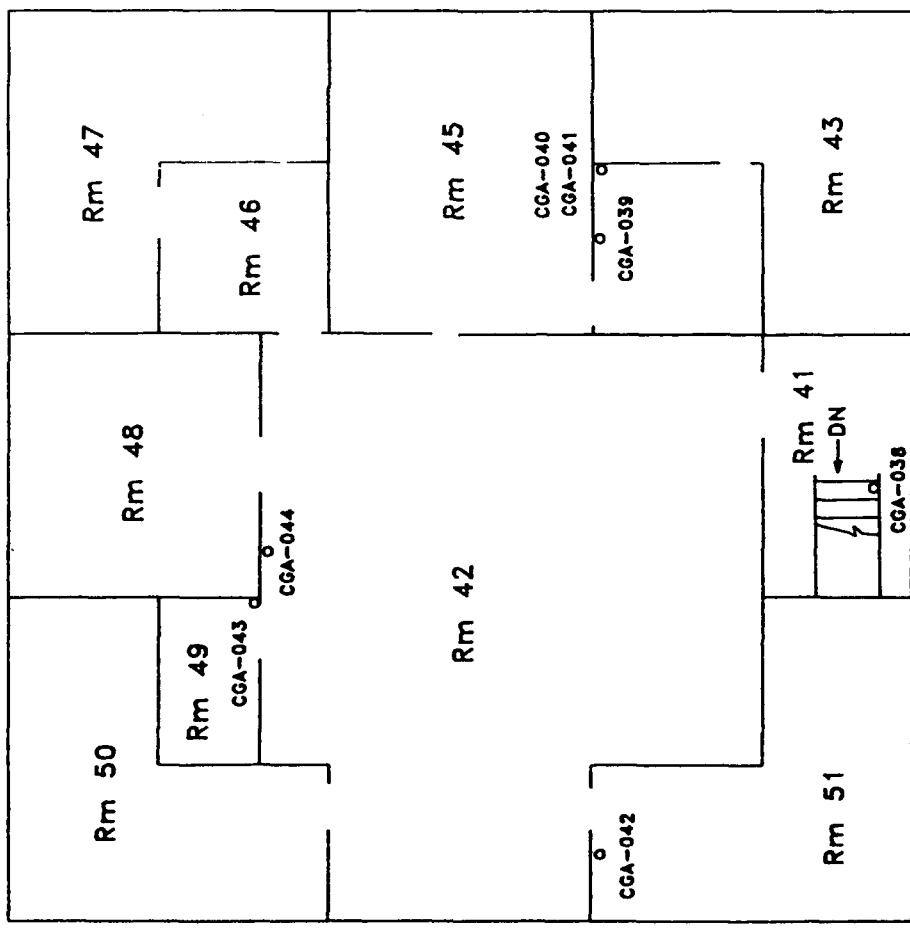
Figure 3.1-3

FLOOR PLAN & SAMPLE LOCATIONS
BLDG 991, THIRD FLOOR
FT. POINT U.S. COAST GUARD STATION
ASBESTOS SURVEY

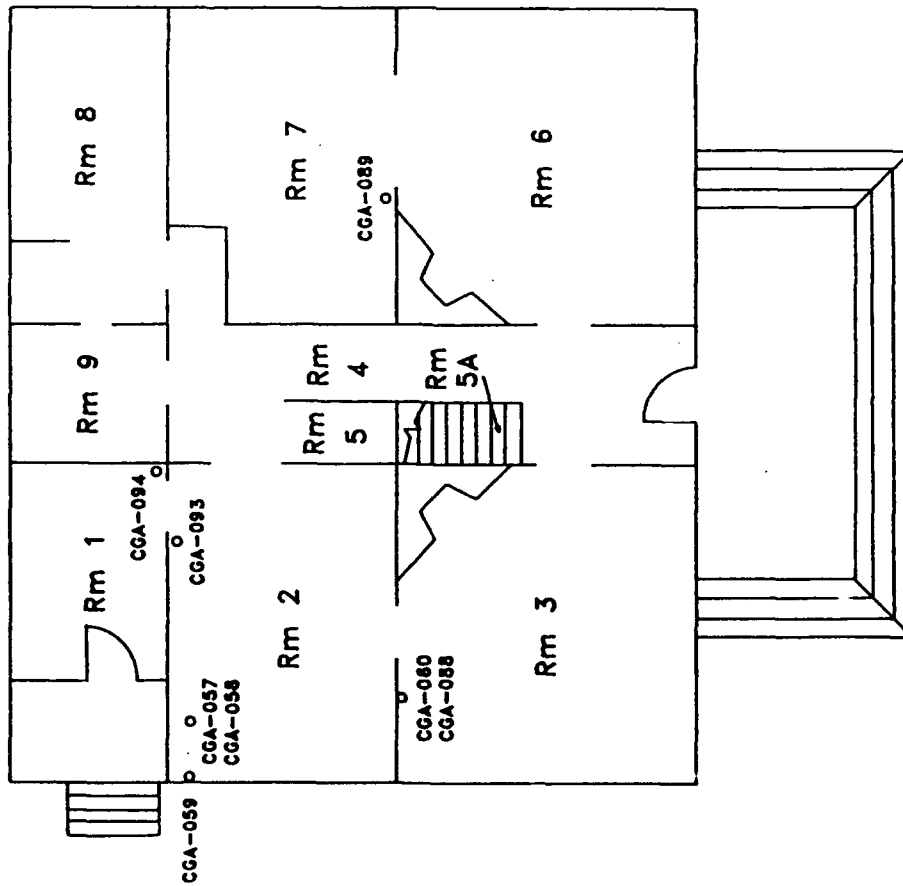
Figure 3.2-2

FLOOR PLAN & SAMPLE LOCATIONS **BLDG 992, FIRST FLOOR** **FT. POINT U.S. COAST GUARD STATION** **ASBESTOS SURVEY**

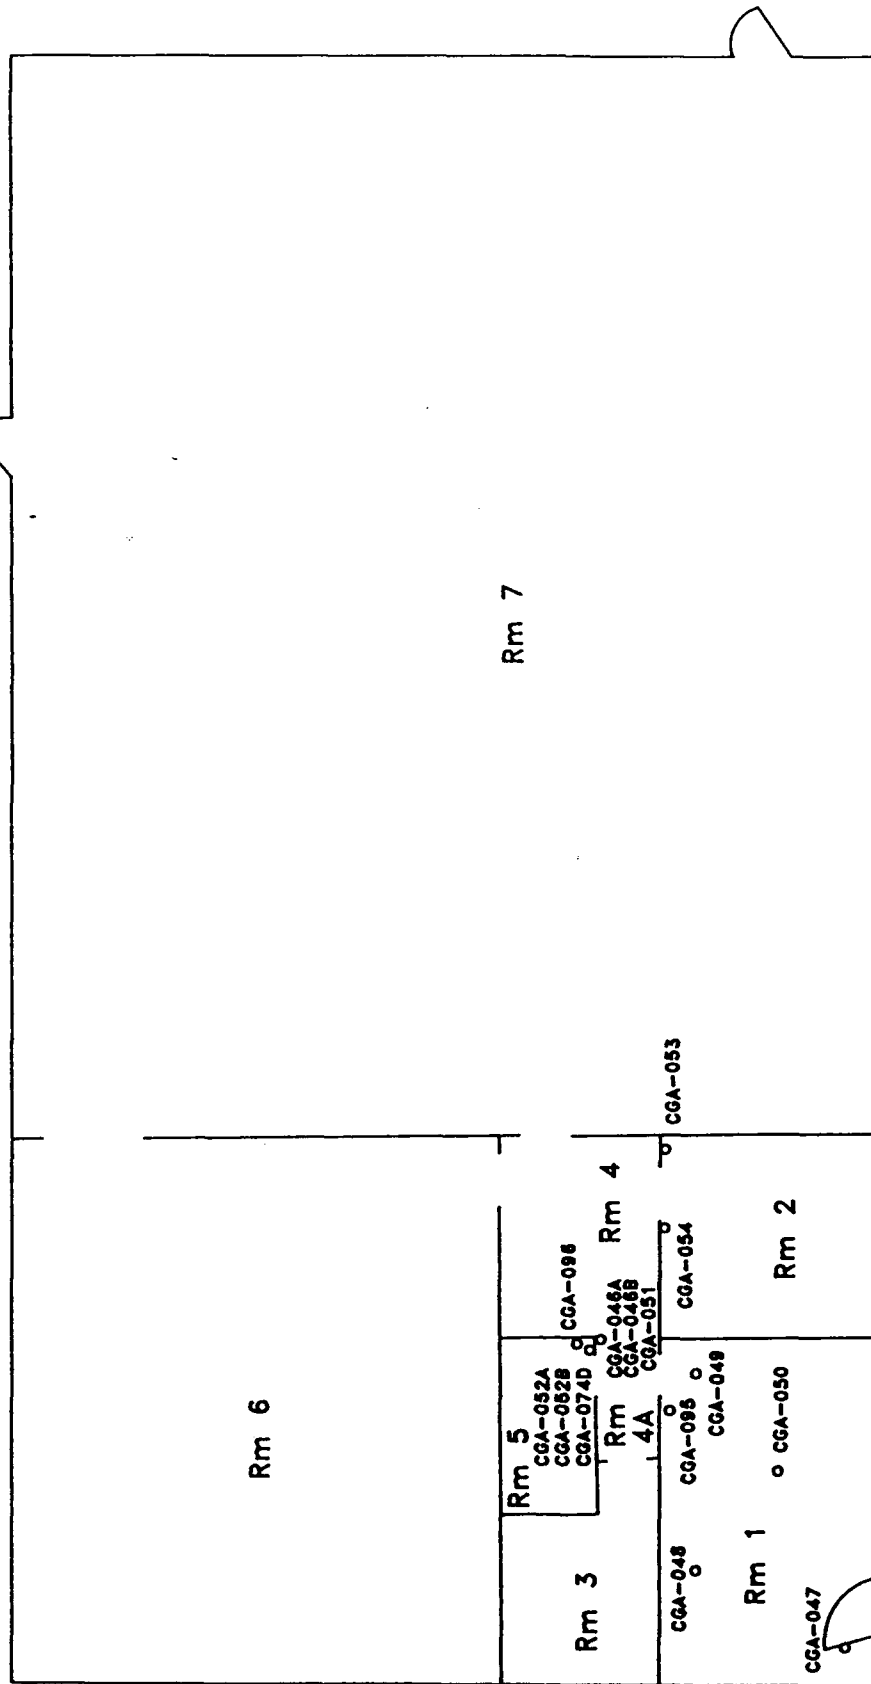
FLOOR PLAN & SAMPLE LOCATIONS
BLDG 984, FIRST FLOOR
FT. POINT U.S. COAST GUARD STATION
ASBESTOS SURVEY

Sample CGA-049 was taken from one of two types of ceiling panels in Room 1. Laboratory analysis of this sample indicates 1-5 percent chrysotile asbestos content. Ceiling tiles are found only in Room 1.

Both nonfriable samples testing positive for asbestos are associated with 9-in. floor tile found in Rooms 1, 3, and 4A. The samples were taken from tile in Room 4A. Sample CGA-046A is from the tile itself, while sample CGA-046B is from the tile mastic. Laboratory analysis indicates 5-10 percent chrysotile asbestos in each of the samples.
